Assessment of a High-Velocity Fabric Filtration System Used to Control Fly Ash Emissions

EPA-600/7-79-094
April 1979

EPA DEMONSTRATION OF THE ENVIRO-SYSTEMS FABRIC FILTER SYSTEM
AT KERR FINISHING DIV. FABRICSAMERICA, CONCORD, NORTH CAROLINA

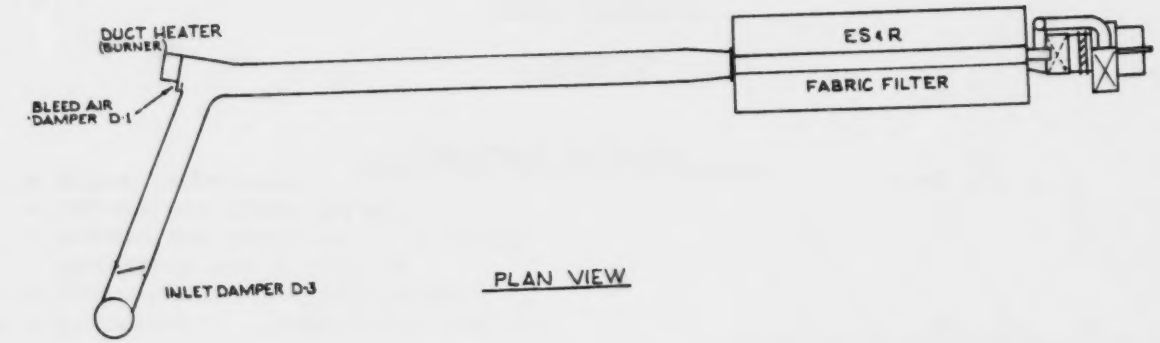
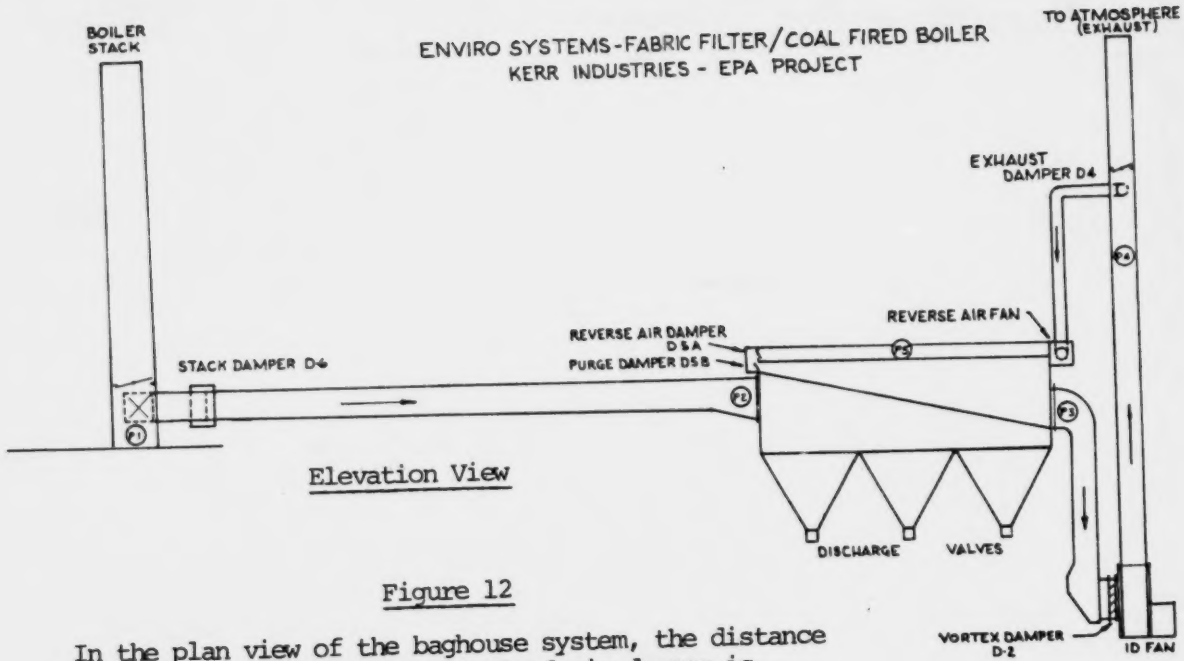
Figure 12

In the plan view of the baghouse system, the distance between the inlet damper and bleed-air damper is different on the two houses.
